WELL SERVICE STANDARD INSTRUCTION  
FEEDBACK FORM

BONGKOT UNIT FIELD

W.S.I. No: 0016 01 00

**TECHNICAL SUBJECT:** Wellhead ring groove corrosion / repair.

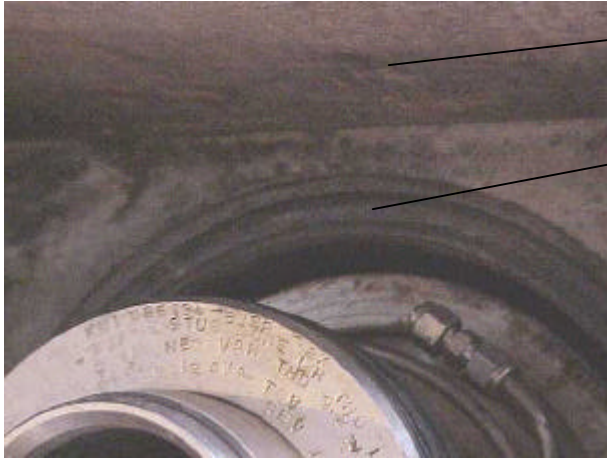
Figure 1

Upon closer inspection, it was found that 3 such wellheads were corroded (BK9-MW, BK-HW and BK9-GW) to such an extent that the ring grooves would not hold pressure. The worst corrosion (BK9-GW) was estimated to be between 5 and 6 millimeter metal loss.

Adjacent Production tree

RX-49 ring groove treated with Belzona 1111.

Due to height restriction and close proximity of adjacent tree, no standard machinery available to clean ring groove.

The Supply Company recommended that we install the Belzona 1111 into the ring groove then allow for time to cure before installing the Production trees. This was felt to be too much of a risk as if the dried Belzona 1111 was not completely smooth and uniform, we would have great difficulty in obtaining a pressure test of the connection. If the pressure test had failed, we would have been in a worse position as we would then have to find a way of removing the Belzona 1111 from the ring groove prior to re-trying the above procedures. We decided to tighten the Production tree to the wellhead whilst the Belzona 1111 was in its liquid state. See figures 1 and 2.

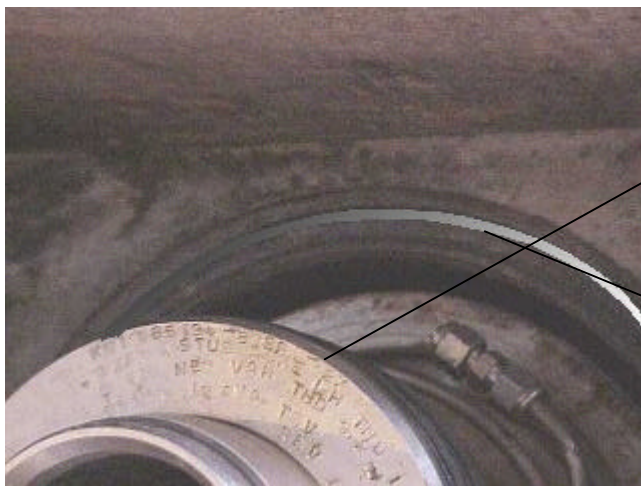
Figure 2

The corrosion problem was first seen when the drilling riser / BOP package was installed on well BK9-MW. The ring groove was heavily contaminated with rust / corrosion and took several hours to clean with emery paper. The drilling package was pressure tested and a satisfactory test was obtained. After the well was completed, the Production tree was installed but failed to hold its pressure test of the ring groove (the studs / nuts were torqued with the use of a ring spanner and sledgehammer).

Tubing Hanger neck w/ DA carrier.

RX-49 corroded ring groove cleaned and ready to receive the Belzona 1111.

degrease the affected ring grooves. See figures 1 and 2. This took about 8 hours to accomplish. One problem that was encountered was that the ring grooves, once cleaned, had to remain completely dry and free from water ingress. This proved problematic as offshore there is continual wash down operations ongoing both on the rig floor and also through out the wellhead platform. We also had to plan the jobs with Production to allow for shutting in adjacent wells during the heavy lifting operations (lowering the Production trees to the wellheads). The actual placement of the Belzona within the ring groove was also a problem as there is only a few millimeters of gap between the adjacent wellhead and the ring groove. The best tool found for this job was the human finger and was used very successfully.

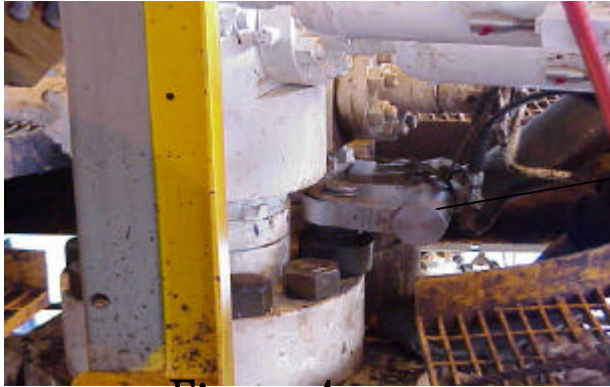
Figure 3

1. Not enough torque was being generated through the studs / nuts of the Production tree to allow for the ring gasket and the DA carrier to be fully energized. This was apparent as the connection leaked at a higher pressure the tighter the flange became. We eventually had the 2 mating surfaces (the bonnet of the Production tree and the upper section of the wellhead) touching one another. The solution to this was to acquire a hydraulic torque wrench from abroad that would give exact torque readings and would ensure the connection was tightened to API specifications (which is not possible when using a ring spanner and sledgehammer). See figure 3.

Hydraulic torque wrench allowed for the exact torque to be applied through the tree/ RX-49 gasket and the DA carrier.

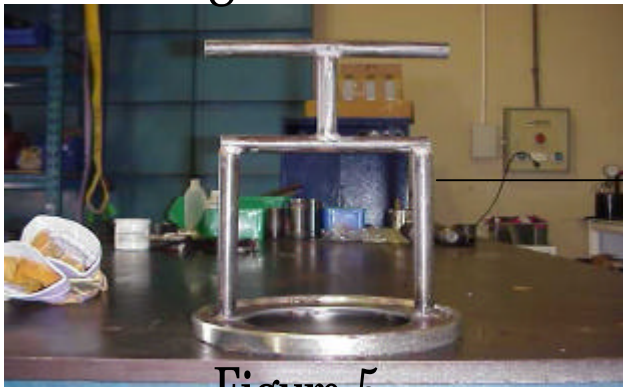
Figure 4

RX-49 ring groove cleaning tool. Handle extension added to allow for height of tubing hanger neck.

Manual tools had to be used for the cleaning of the ring groove. For this we took some old ring gaskets and had them modified at a local machine shop so that tungsten cutters were imbedded into the gasket and a suitable frame was welded to the top of the gasket to allow for rotation past the top of the tubing hanger neck. These tools were tested in the Songkhla workshop and it was felt that they would be adequate for the job. See figures 4 and 5.

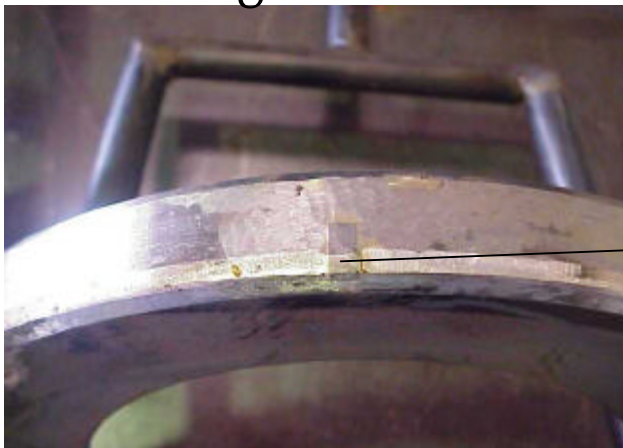
Figure 5

Tungsten cutter inserted into RX-49 gasket to aid in removal of corrosion in the ring groove.
