# TECHNICAL REPORT

**BELZONA CERAMIC S-METAL**

REPORT No. BGN-92-6392

VERITEC
DET NORSKE VERITAS INDUSTRI NORGE AS

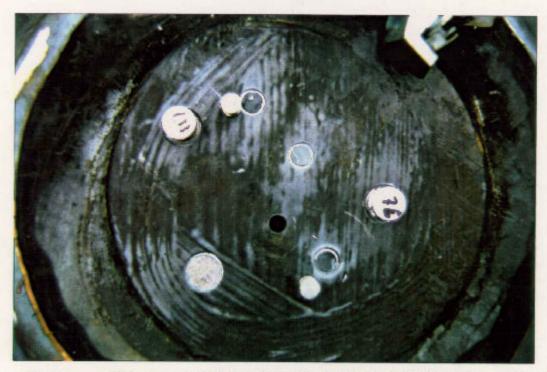
The visual examination of the coating after the test period confirmed that the coating did not show any tendency to general or local breakdown. No indications of blistering, undercutting or disbonding could be observed, ad is evident from Fig. 1.

The general condition of the Belzona Ceramic S-Metal after termination Fig. 1. of the testing.

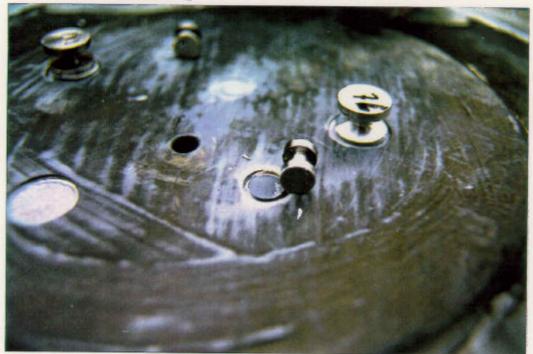
The adhesion test, Fig. 2, showed that the adhesion properties had not been weakened as a result of the exposure test. Values higher than 7 MPa were recorded. At this stress the dolly broke in the glue between the dolly and the coating.

Fig. 2. Dolly testing for determination of adhesion strength.
