# THE BELZONA 1591 PROTECTIVE COATING SYSTEM EVALUATION APPLICATION : HOT QUENCH OVERHEAD TRIM COOLERS

Equipment: Hot quench overhead trim coolers

16 August 1999

# EVALUATION OF BELZONA 1591 FOR APPLICATION IN THE HOT QUENCH OVERHEAD TRIM COOLERS: SYNTHOL

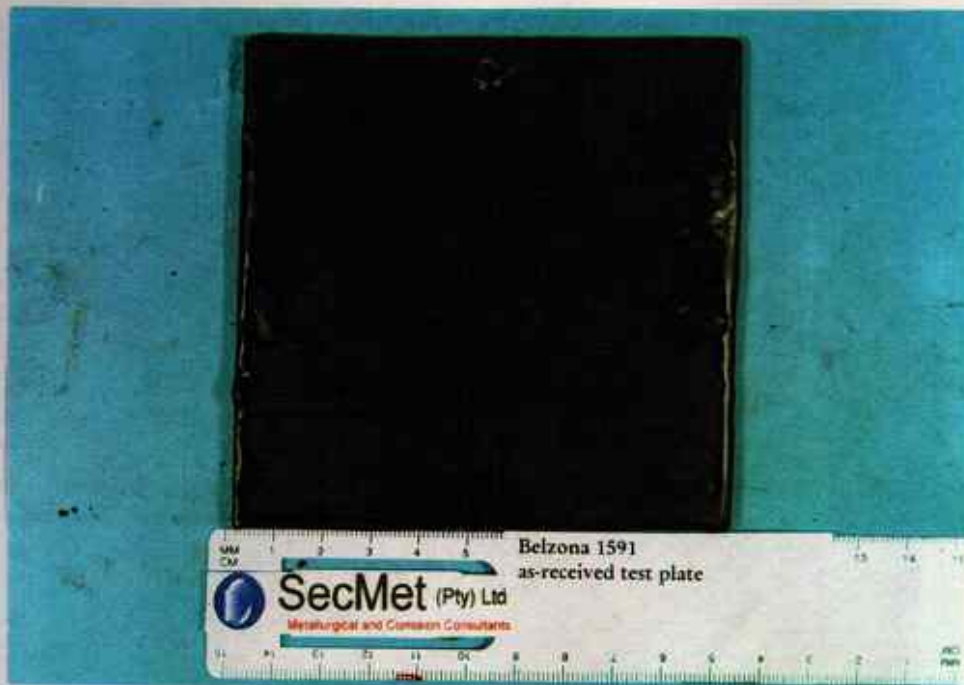
Figure 1. As-received Belzona 1591 test plate.

Coating system	Color	Application as-received sample	Remarks
Belzona 1591	Semi-gloss dark brown to black	Brush applied	1. Non-uniform ripple finish. 2. Runs and sags evident. Figure 1.

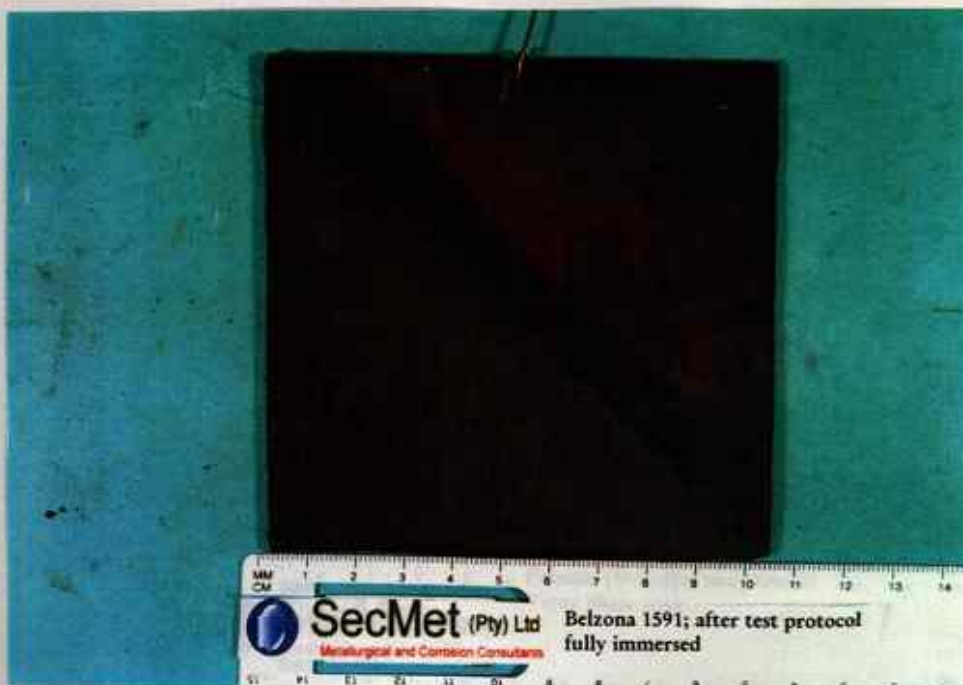
Figure 2. Belzona 1591 test panel after accelerated test protocol. : fully immersed

Coating system	Color	Remarks	Illustration
Belzona 1591 <i>fully immersed</i>	brown rust stained	1. Copious amounts of rust formation at scribe indicating media to be corrosive.	Figures 2,3
Belzona 1591 <i>vapor zone</i>	brown	1. Superficial rust formation evident along scribe.	Figures 4,5

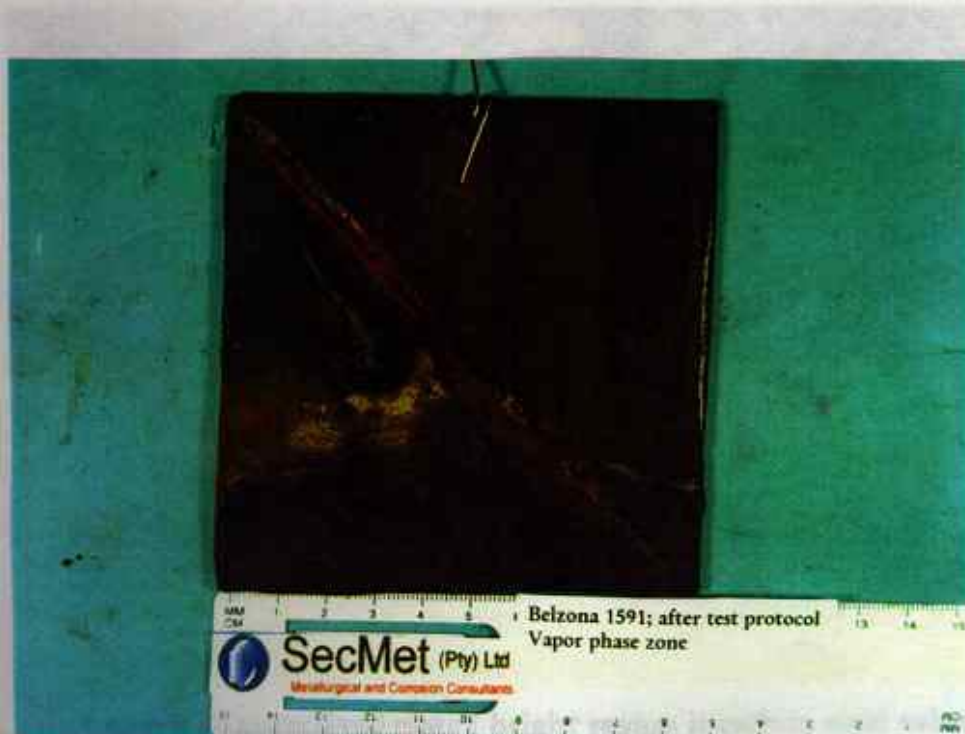
Figure 4. Belzona 1591 test panel after accelerated test protocol. : vapor phase

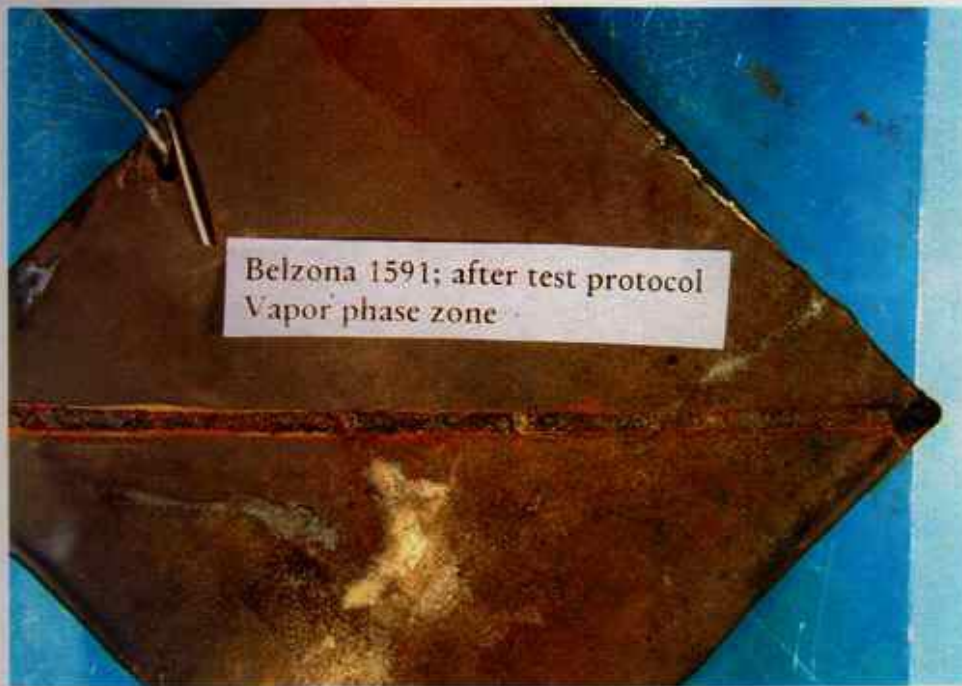
Figure 5. A close-up view of scribe : Test plate in the vapor phase.

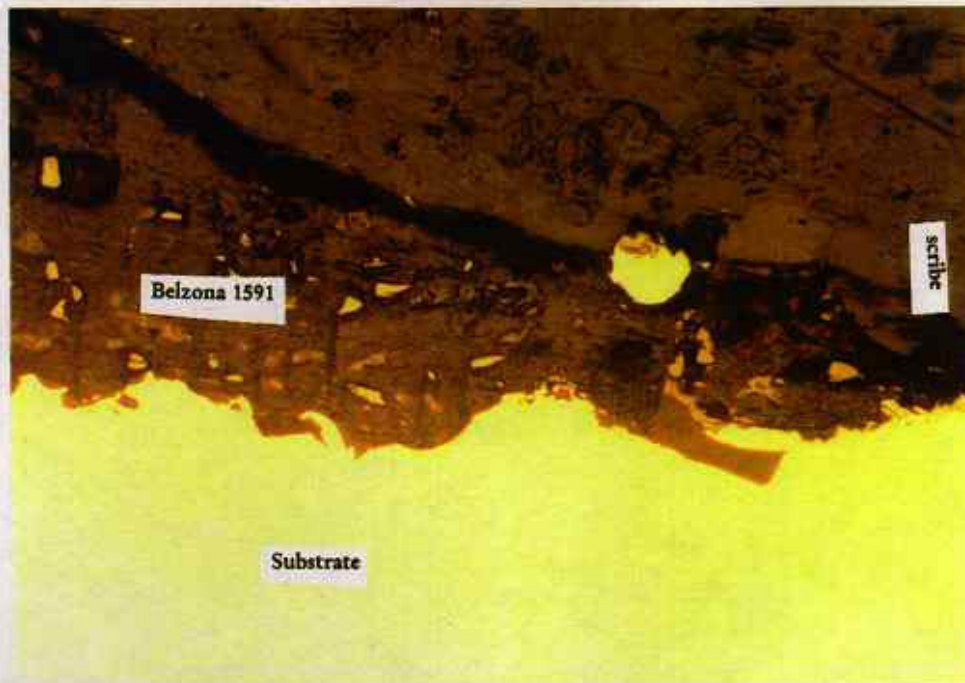
Figure 9. Micro-graph of coating system: vapor phase , *Coating system still intact after test protocol (100X)*

Coating system	Characteristic of post test panel	Illustration
Belzona 1591 vapor zone	Coating intact to substrate. Corrosion on scribe was minimal in the vapor zone	Figures 9, 10
