Nexen Buzzard Platform Amine Line – Surface Preparation and Coating Application

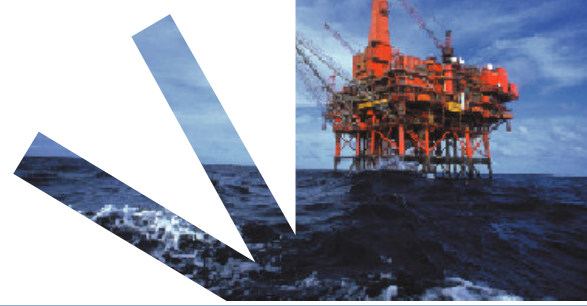
- Existing Amine line runs at an operational temperature of +70deg C to 110deg C and required a new external coating.
- Amine line required to remain 'live' throughout surface preparation and coating application stages.
- Works to be completed in December – low ambient temperature and higher winds.

- Product selection investigation completed and "best for purpose" product offered and agreed with Nexen was Belzona 5851.
- Belzona 5851 can be applied to live "hot" lines and will cure on surface temperatures above 70deg C.
- Simple application method – brush.
